# **Property Condition Assessment**

Audubon Road Commercial Office Property  
Audubon Road, Wakefield, MA

September 11, 2012  
NAA Project No. 0130010

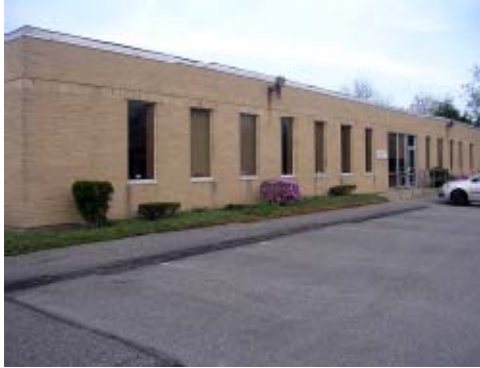
**Exterior Wall 1**  
Entry Overview

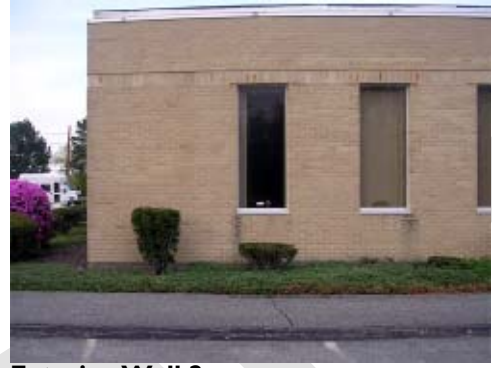
**Exterior Wall 2**  
Wall at corner/end

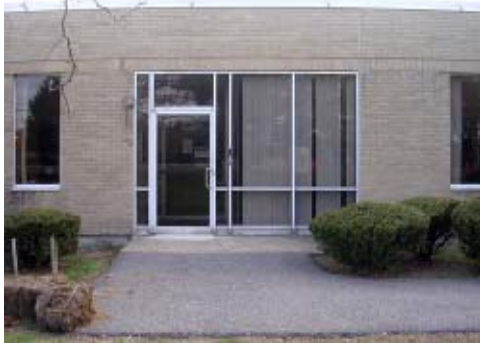
**Exterior Wall 3**  
Main Entry Storefront

Calking around the window frames and storefront framing is integral and functioning, but appears to be brittle generally and should be removed and replaced in the near term.

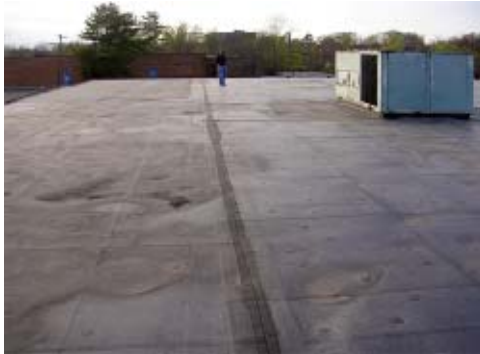
No CFC refrigerant usage was noted or reported. RTUs are due for regular maintenance; drain line, drip pan and coil cleaning, and filter replacement.

**Roof 1**  
Roof Top Unit One

It should be anticipated that minimally, condenser coils for the smaller AC units will require replacement and that the roof top unit compressors will require rebuilding or replacement in the near term.

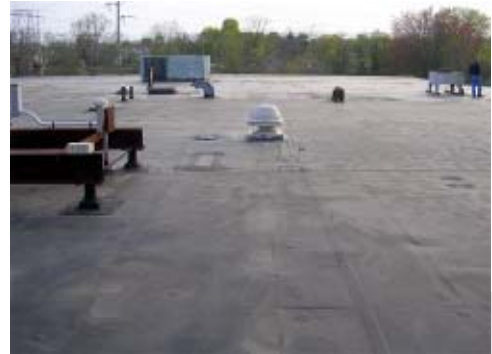
As noted above, these units appear to be in working order presently. A single, roof-mounted exhaust fan for the laundry and toilet room areas is not working.

**Roof 2**  
Exhaust Fan

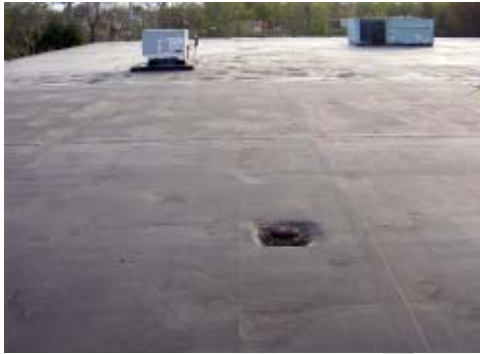
**Roof 3**  
Typical Roof Drain

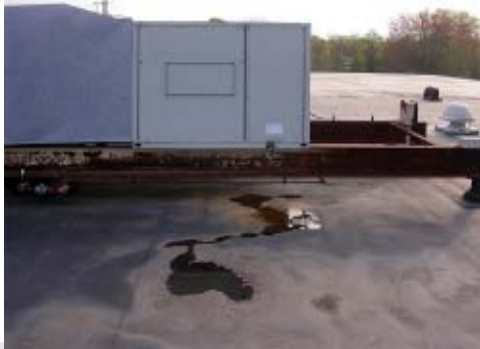
**Roof 5**  
Roof Top Unit Two

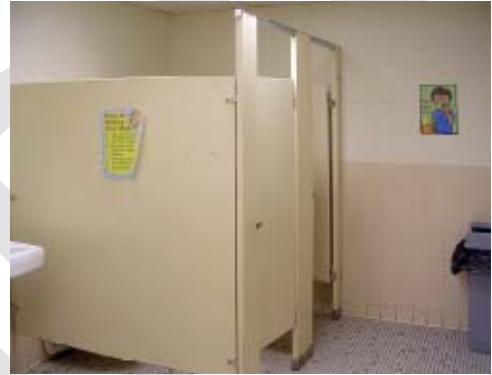
**Toilet Rooms 2**  
Typical Stalls

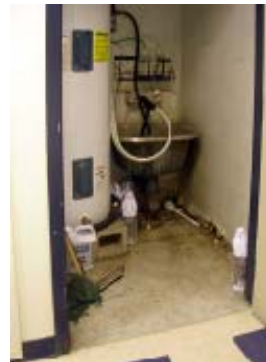
**Water Heater 1**  
Hot Water-1
